Manhole Inspection Summary

Manhole # S25E__059MH

Insp Date: **8/7/07 11:51 AM**

Location Address: **223 CARROLLTON AVE**

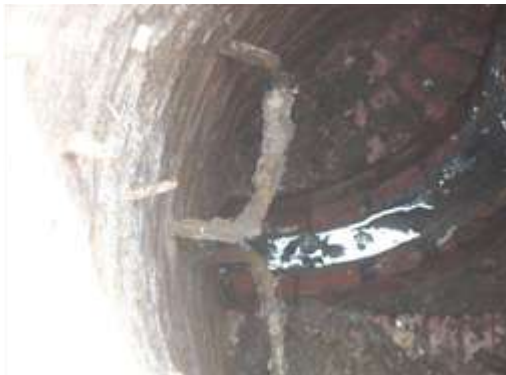
Defect 2

☒ **Evidence Of Surcharge** Depth: **4** (ft.) ☐ Active Surcharge Present

SURCHARGE EVIDENCE ON STEPS

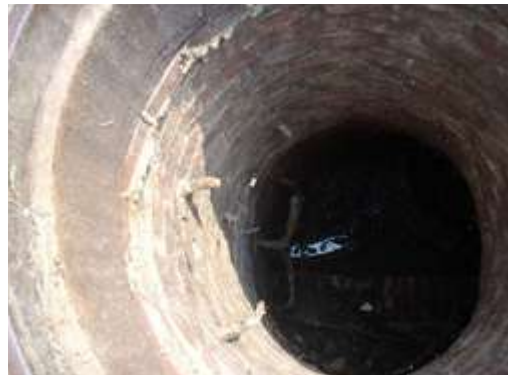
Defect 1

Count: **2** Missing: **4** ☒ **Corroded**

MISSING AND CORRODED STEPS

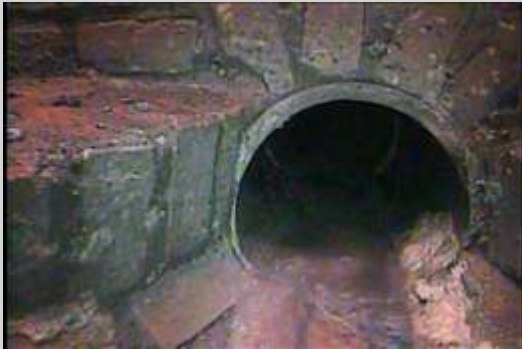
12 O'Clock Outflow

8 in. Circular Gravity Sewer
Pipe Out @ 12 O'Clock

Pipe Height: **7.2** (in.) Rod and Bar (Angled)
Pipe Material: **Clay** ☐ Pipe Lined
Invert Depth: **9.17** (ft.) Flow Characteristics: **Slow**
Deposits: ☐ None ☐ Mud ☒ **Sludge** ☐ Debris ☐ Grease
Silt Depth: **1** (in.) Deposits Extent: **Light**
Infiltration: **None** Pipe Seal Cond: **Sound**

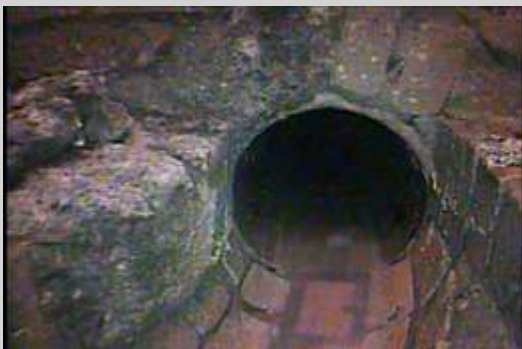
3 O'Clock Inflow

8 in. Circular Gravity Sewer
Pipe In @ 3 O'Clock

Pipe Height: **8.4** (in.) Rod and Bar (Angled)
Pipe Material: **Clay** ☐ Pipe Lined
Invert Depth: **9.11** (ft.) Flow Characteristics: **Slow**
Deposits: ☒ None ☐ Mud ☐ Sludge ☐ Debris ☐ Grease
Silt Depth: (in.) Deposits Extent:
Infiltration: **None** Pipe Seal Cond: **Sound**

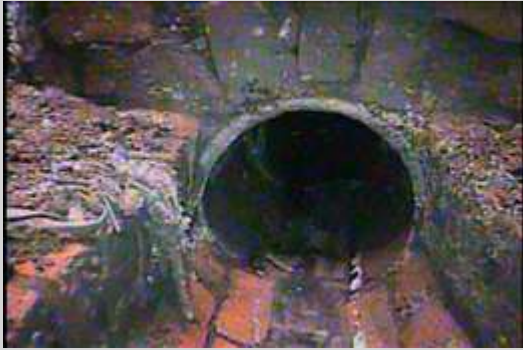
9 O'Clock Inflow

8 in. Circular Gravity Sewer

Pipe In @ 9 O'Clock

Deposits: ☒ None ☐ Mud ☐ Sludge ☐ Debris ☐ Grease

Infiltration: **None** Pipe Seal Cond: **Sound**

Connects To: **Dead End**
